REPORT ON SITE SERVICES STUDY

TORONTO ZOO

**PARADIGM ENGINEERING GROUP INC.
Project No: 850**

September , 1999

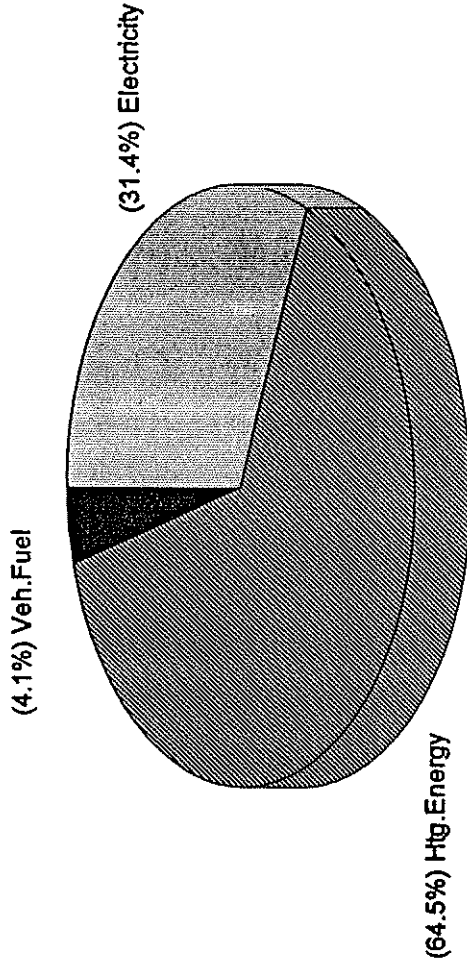
Energy Consumption

ALL FACILITIES
1997 Actual ENERGY CONSUMPTION & COST

Total 32,417.1 equivalent megawatt hours
Total 7,375 tonnes CO2

NOTE: Htg Energy includes natural gas & heating oil; Veh. Fuel includes gasoline, diesel and propane.

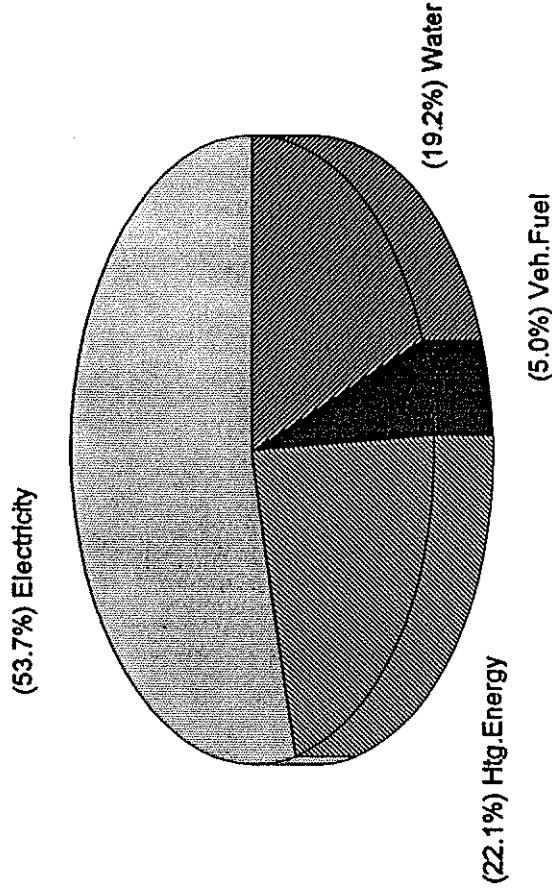
Energy Cost

Total \$1,355.4 millions
